Capital Reserve Fund Recommendations

Glenkirk Estates HOA
Gainesville, Virginia

10 October 2007

CAM SERVICES, INC
3949 Pender Drive, Suite 150
Fairfax, Virginia 22030

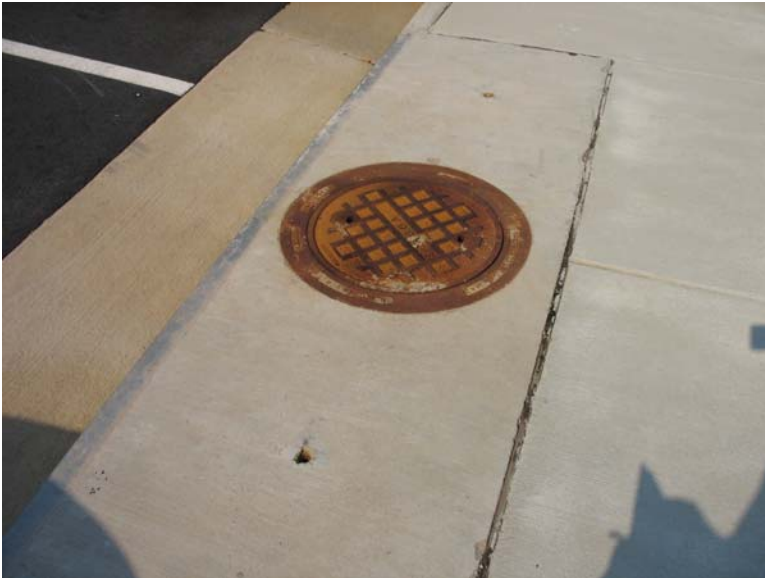
During our inspection, we noted two holes in the concrete at the storm sewer inlet near the pool area playground (Photo 1) – these holes should be filled to prevent further damage. Also, there is a crack in the sidewalk leading to the playground, adjacent to 8724 Lords View Loop (Photo 2). All other sidewalks appear to be in excellent condition.

Photo 1 – Holes in concrete at storm sewer inlet, pool parking lot.

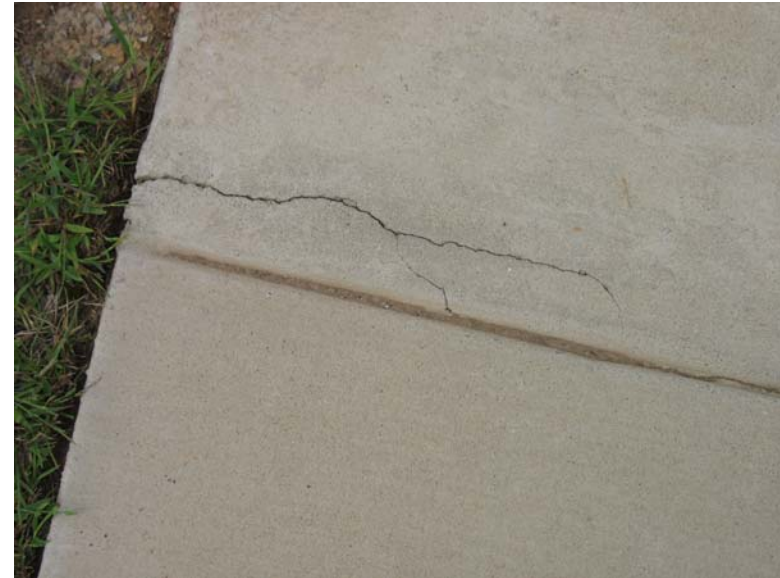
Photo 2 – Cracked sidewalk section adjacent to 8724 Lords View Lp.

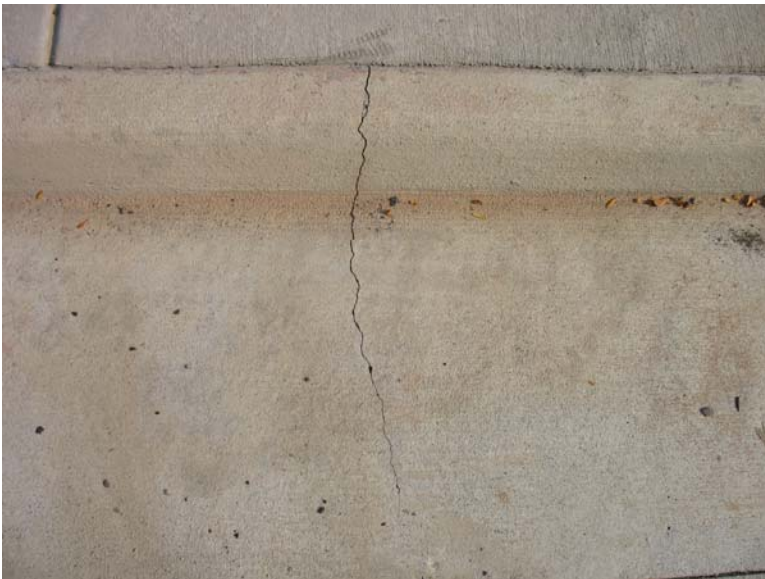
During our inspection, we noted a minor crack in the curb and gutter section at the southwest corner of the pool parking lot (Photo 3). All other curb and gutter sections appear to be in excellent condition.

Photo 3 – Cracked curb and gutter at pool parking lot, SW corner.

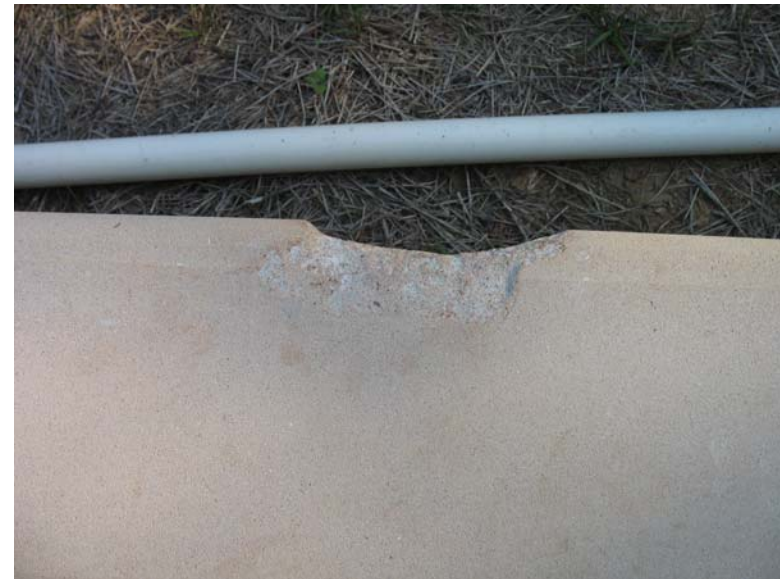
The entry feature on the south side of Rollins Ford Road, opposite the club house, is in excellent condition. We noted a broken section of precast concrete wall cap near the gazebo that may need to be replaced (*Photo 4*).

Photo 4 – Broken wall cap at entry feature south of Rollins Ford Rd.

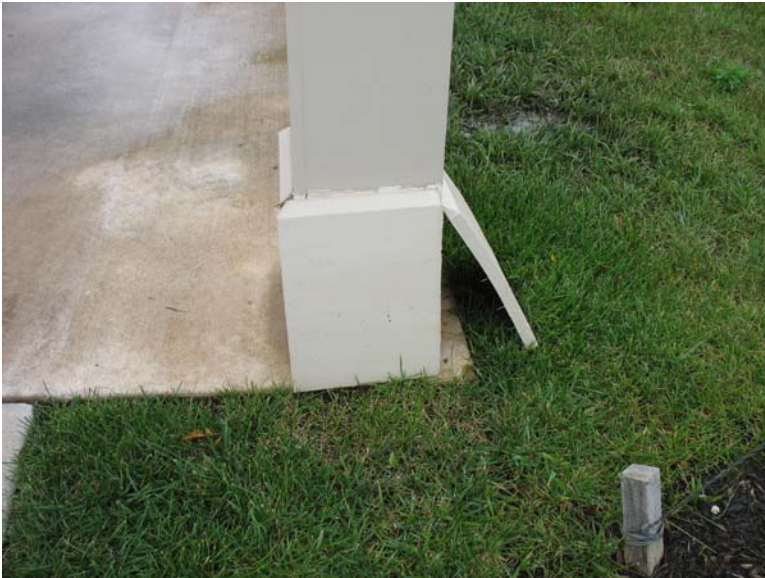
All gazebos appear to be in excellent condition. The gazebo at the entry to the pool deck contains a loose section of wood trim surrounding one of the timber columns (Photo 5). This section should be reattached to prevent further damage.

Photo 5 – Damaged wood trim at pool entry gazebo.

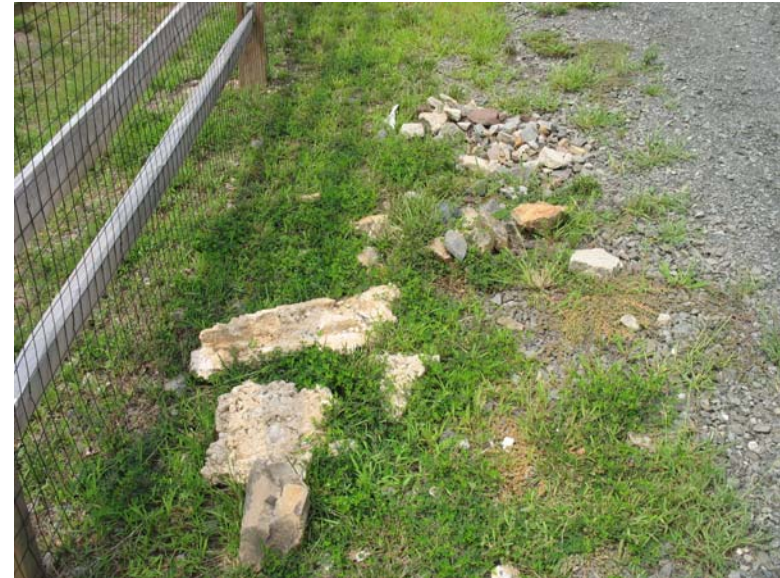
During our inspection we noted concrete debris and stones scattered along the side of the road near 15050 Anchor Mill Place (Photo 6) and near the culvert behind 8610 Wales Court. This debris should be removed. We also observed grass growing on the road, such as at the east end of the ponds. It is important to control all plant growth along the road to allow access for service vehicles and extend the useful life of this component.

Photo 6 – Concrete and rock debris near 15050 Anchor Mill Pl.

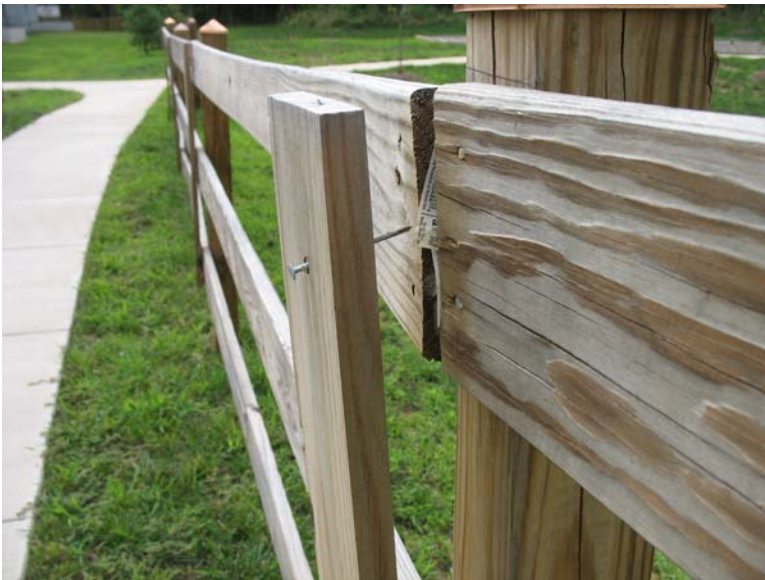
The wooden guardrails behind 8720 Lords View Loop are essentially a 3-rail fence consisting of 1x6 rails, 4x4 posts and 1x4 fascia trim attached to each post. The guardrails appear to be in very good condition. We noted there is a loose fascia trim piece on the post at the northwest end of the guardrail that should be reattached (*Photo 7*). Also in this area is a bowed top rail which may require replacement. At the southwest end, the fascia trim piece is missing on the post – this is only a cosmetic issue.

Photo 7 – Loose fascia trim on guardrail behind 8720 Lords View Lp.

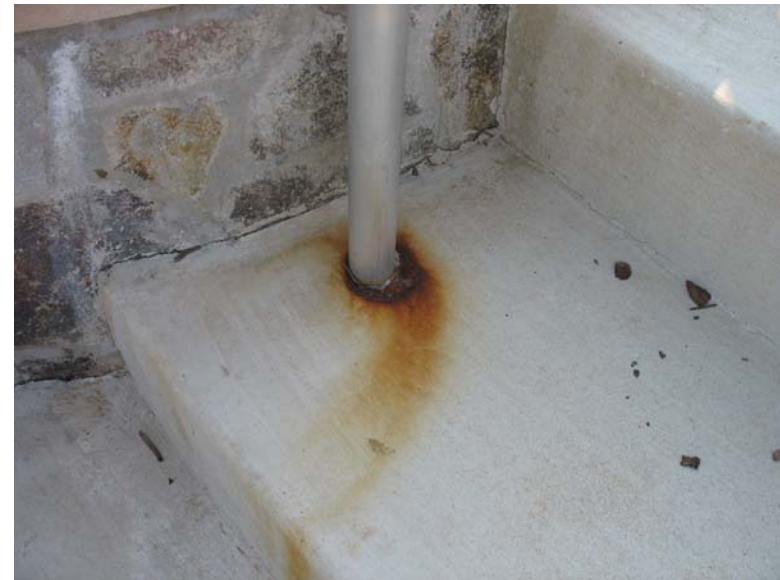
The metal handrails at the club house appear to be in excellent condition aside from rusting at the base of select posts (*Photo 8*). These areas should be repaired to prevent water from pooling at the base of the posts and causing rust to form.

Photo 8 – Rust forming on handrail base at club house entry stairs.

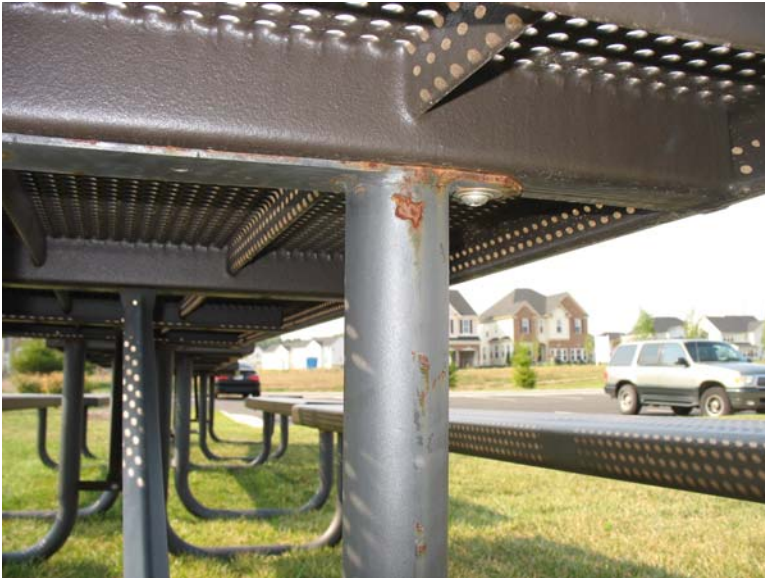
Each picnic table is eight feet in length and made of PVC-coated steel. All tables appear to be in excellent condition. We noted one table contains rust on the steel frame post (Photo 9). It is important to maintain the painted surface of the steel frame on all tables to prevent rust formation and improve the overall appearance.

Photo 9 – Rust forming on picnic table post near pool area.

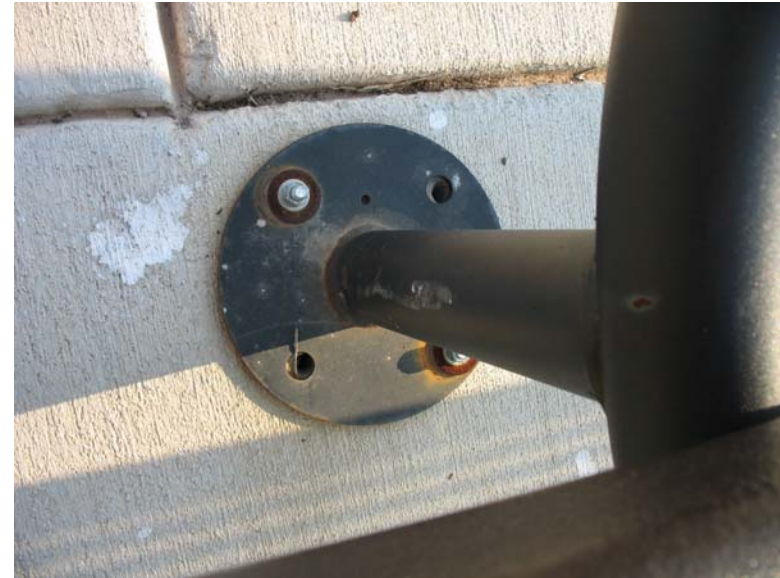
The playground adjacent to the pool contains a large play assembly which appears to be in excellent condition. During our inspection we noted the first platform step at the east end is not secured to the steps of the main assembly. Installation of a bracket may be required to provide greater stability – check with manufacturer. Additionally, the park bench near the pool entry gate is missing two bolts at the base of each post (Photo 10).

Photo 10 – Two missing bolts on park bench post near pool.

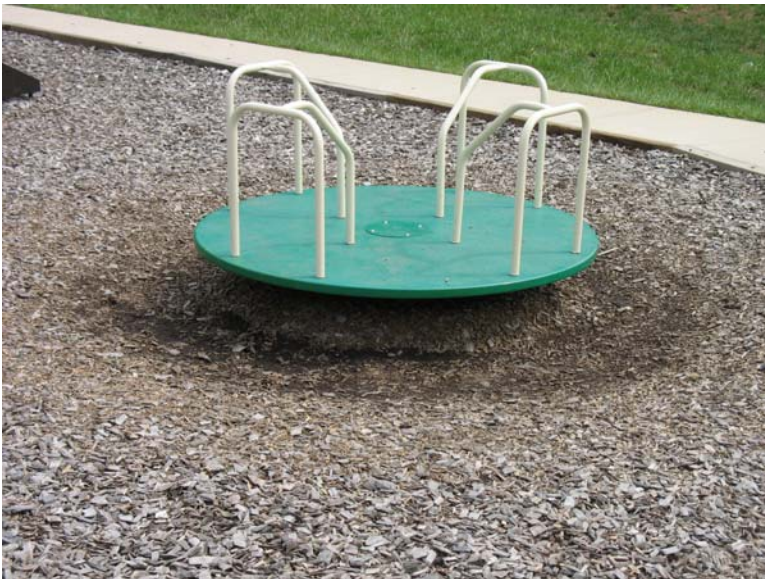
The playground behind 8676 Wales Court consists of a medium play assembly, merry-go-round, swing set, balance beam and two spring riders – all components appear to be in excellent condition. The wood mulch at the swing set and merry-go-round has been worn down and should be replenished to provide an impact absorbing play surface (Photo 11). We also observed an exposed nail at the connection of two timber borders at the south end of the playground (Photo 12).

Photo 11 – Worn mulch at playground behind 8676 Wales Ct.

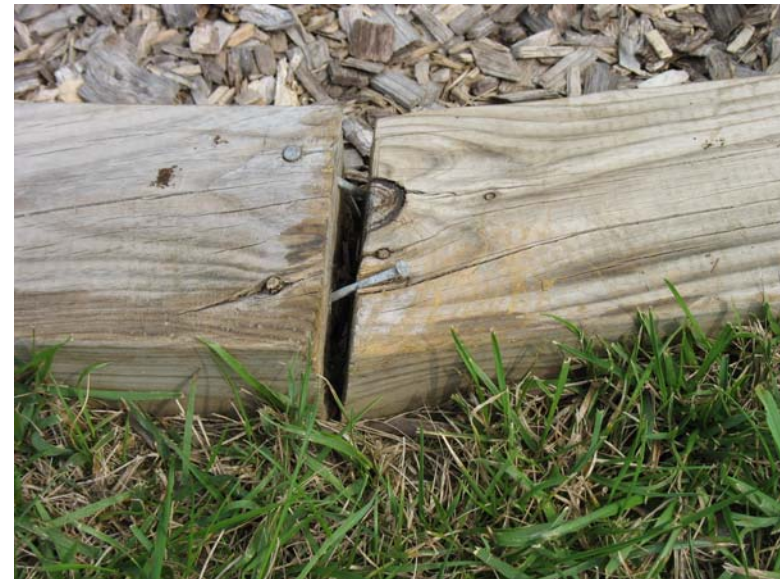
Photo 12 – Exposed nail on playground timber behind 8676 Wales Ct.

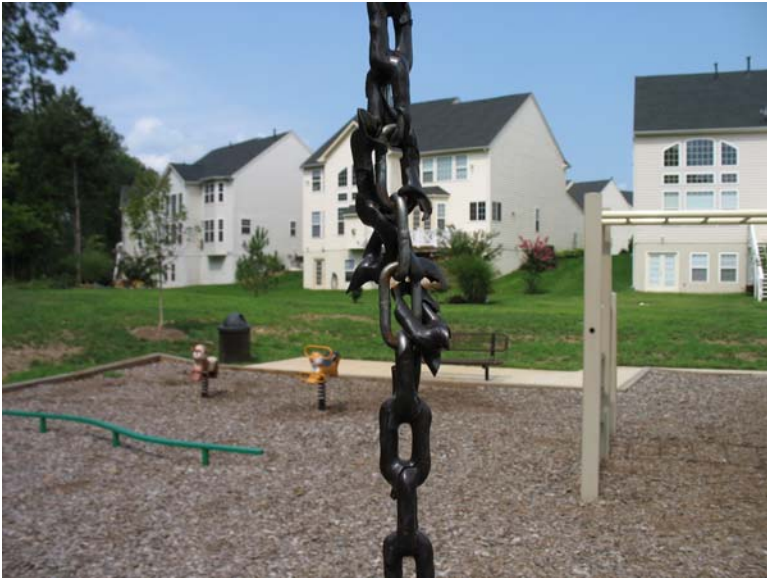
The playground behind 8724 Lords View Loop contains identical equipment to the Wales Court playground, only slightly more worn. We noted damage to the vinyl coating on the swing chains (Photo 13), minor rust on the balance beam and a broken edge on the timber border in front of the slide.

Photo 13 – Damaged swing chain behind 8724 Lords View Lp.

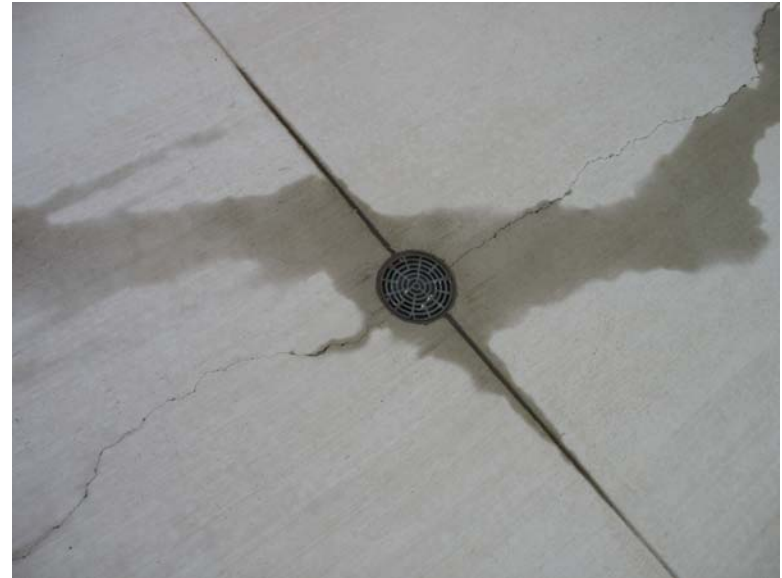
The pool deck appears to be in excellent condition. The only defects noted during our inspection were minor hairline cracks in the concrete around the main pool, such as near the drain at the south end (Photo 14), the fence at the north end and the handrail at the northeast corner.

Photo 14 – Cracked pool deck at south end of the main pool.

We are assigning a total life expectancy of 30 years to the pool deck. However, we recommend funding for 50% replacement every 15 years to cover early repairs.

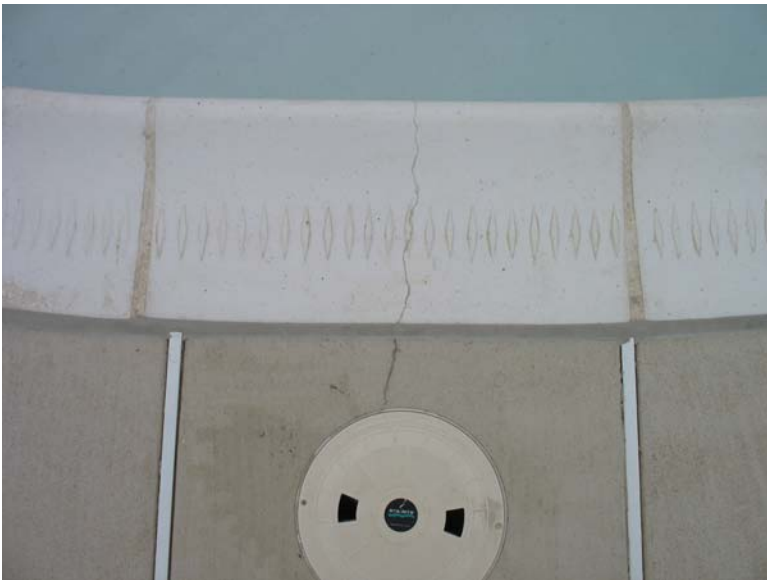
All components appear to be in excellent condition. We noted a minor hairline crack in the coping at the wading pool, extending toward the skimmer at the southeast corner of the pool (Photo 15). The pool equipment consists of components that vary in age and will require replacement in phases.

Photo 15 – Cracked coping at southeast corner of wading pool.

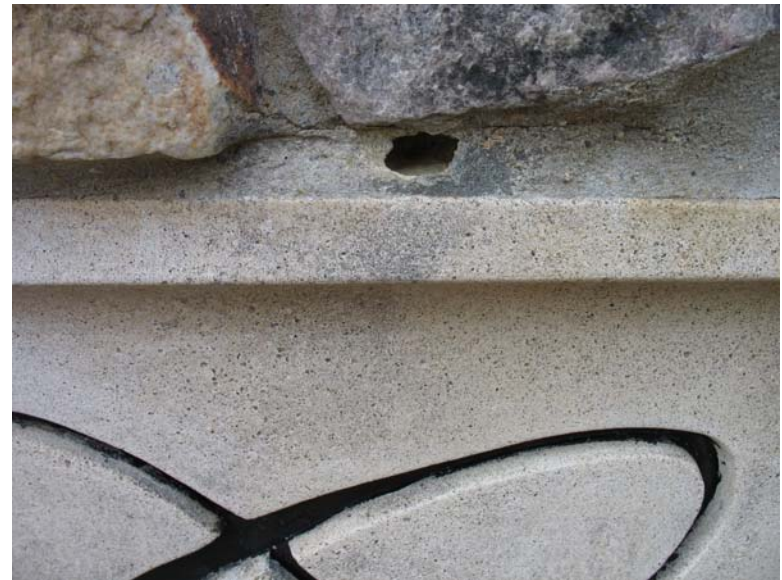
The masonry appears to be in excellent condition on all components. During our inspection, we noted the precast concrete wall caps at the entry feature along Glenkirk Road contain minor hairline cracks along the mortar joint between sections, primarily located above the entry sign. We also noticed a small hole in the mortar near the entry sign, above the letter "G" in "Glenkirk" (Photo 16). These defects may require point-up.

Photo 16 – Hole in mortar above “G” at Glenkirk Road entry sign.

Properly built masonry should last 50 to 100 years, depending on the stone quality and mortar mix. However, periodic point-up of defective or failing mortar may be necessary. Based on our observations, we recommend funding for point-up repairs every ten years.
